## New Activity at the Esfahan Nuclear Complex

By David Albright, Sarah Burkhard, Spencer Faragasso, and the Good ISIS Team

January 29, 2026

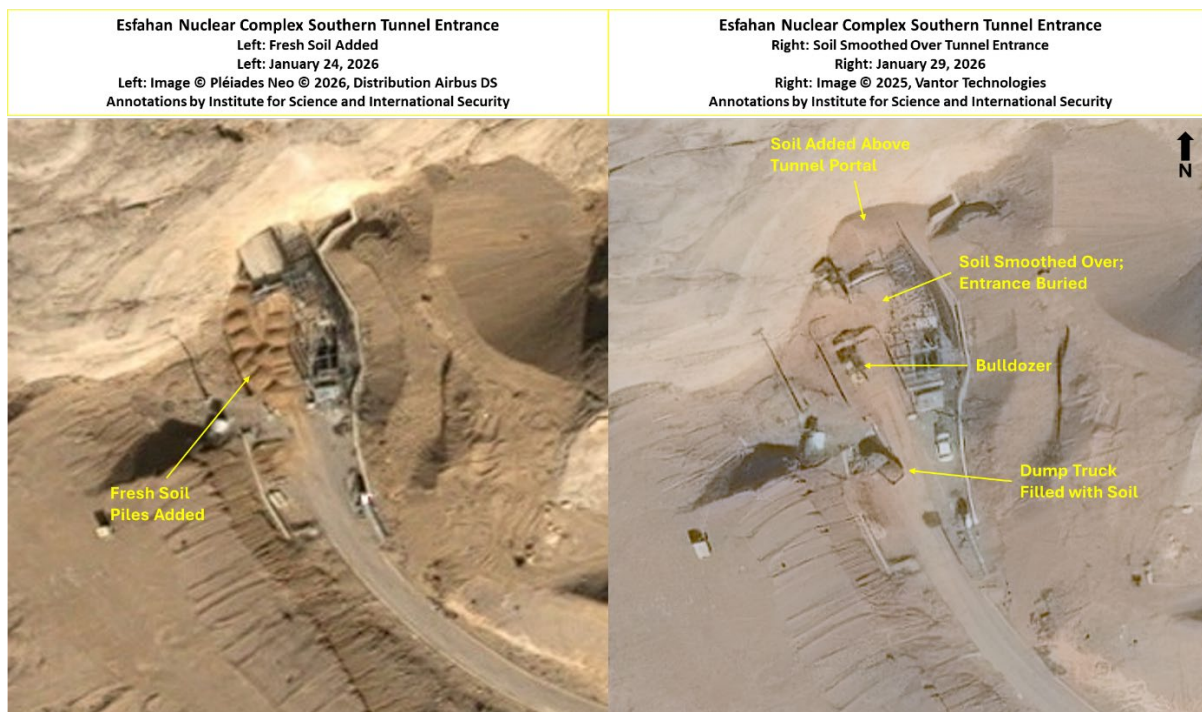
**Figure 2.** Fresh soil heaps appeared outside of the southernmost entrance on January 24 (left). As of January 29, construction vehicles are further burying the tunnel entrance (right).

Satellite imagery taken on January 24 and January 29, 2026, show new efforts by Iran to bury the middle and southernmost tunnel entrances with soil. On January 29, the door serving as entrance to the middle tunnel, as well as the entrance to the adjacent alcove, appeared fully blocked by dirt (see Figure 1). Figure 2 shows heaps of fresh soil outside the southernmost entrance as of January 24. A few days later, construction machinery was working outside the tunnel entrance. More dump trucks can be seen at a nearby staging area being filled with soil or waiting to be filled. A series of dump trucks loaded with soil can be seen on the road leading to the tunnel entrances, presumably to add more soil to the middle entrance. Increased vehicle presence on the road leading to the tunnel entrances was previously noted on January 24. See Figure 3.

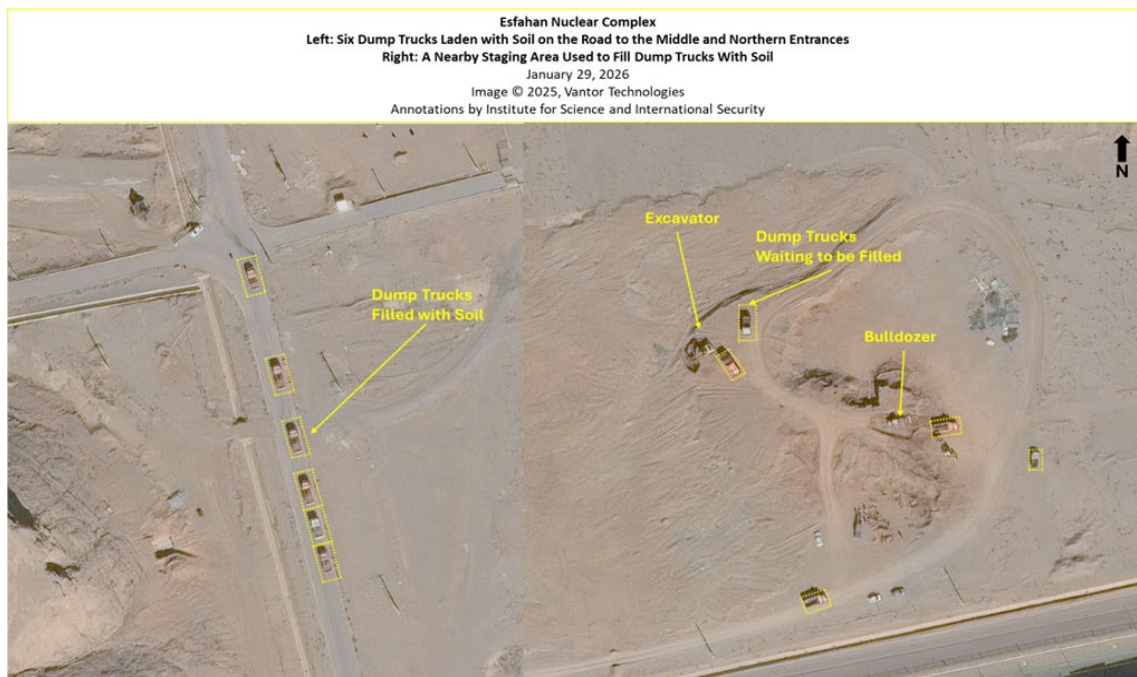
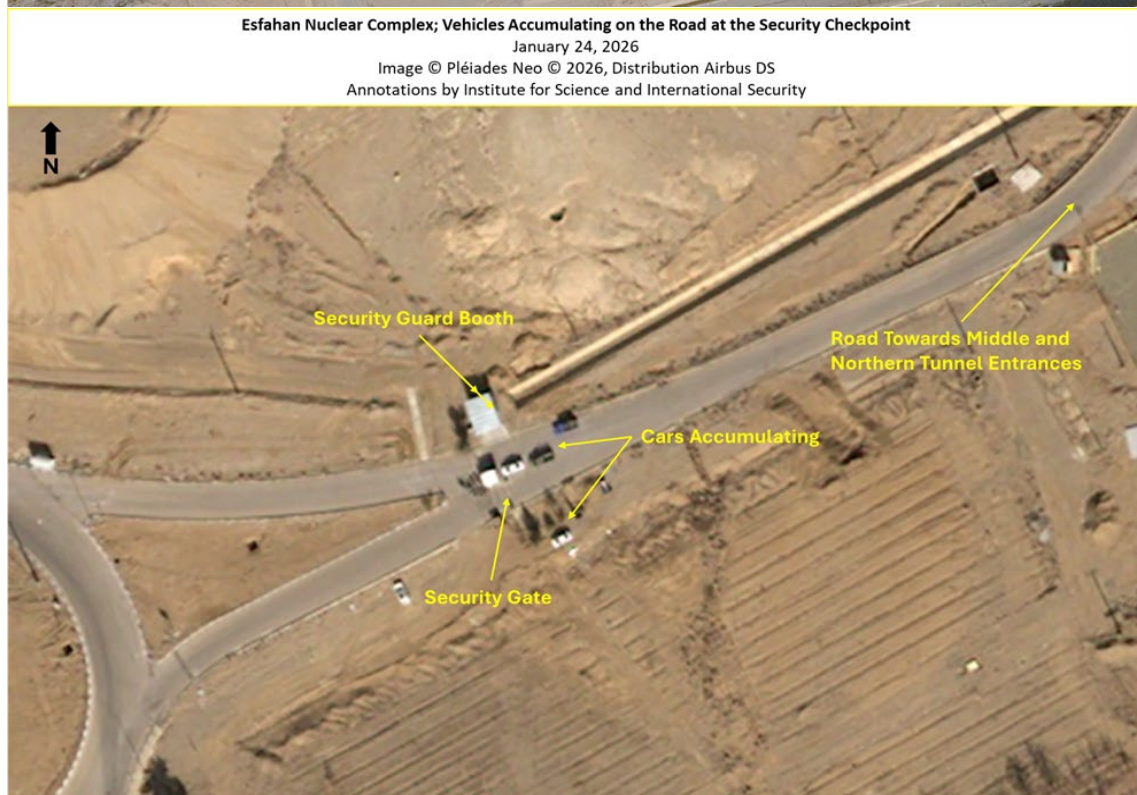
**Figure 3.** Several images showing vehicular activity on the roads to the tunnel entrances. The top image, taken January 29, shows six dump trucks filled with soil driving on the road leading towards the middle and northern tunnel entrances. Nearby is a staging area used to fill the dump trucks. The bottom image shows vehicles at the security checkpoint on the road to the northern and middle tunnel entrances a few days prior.

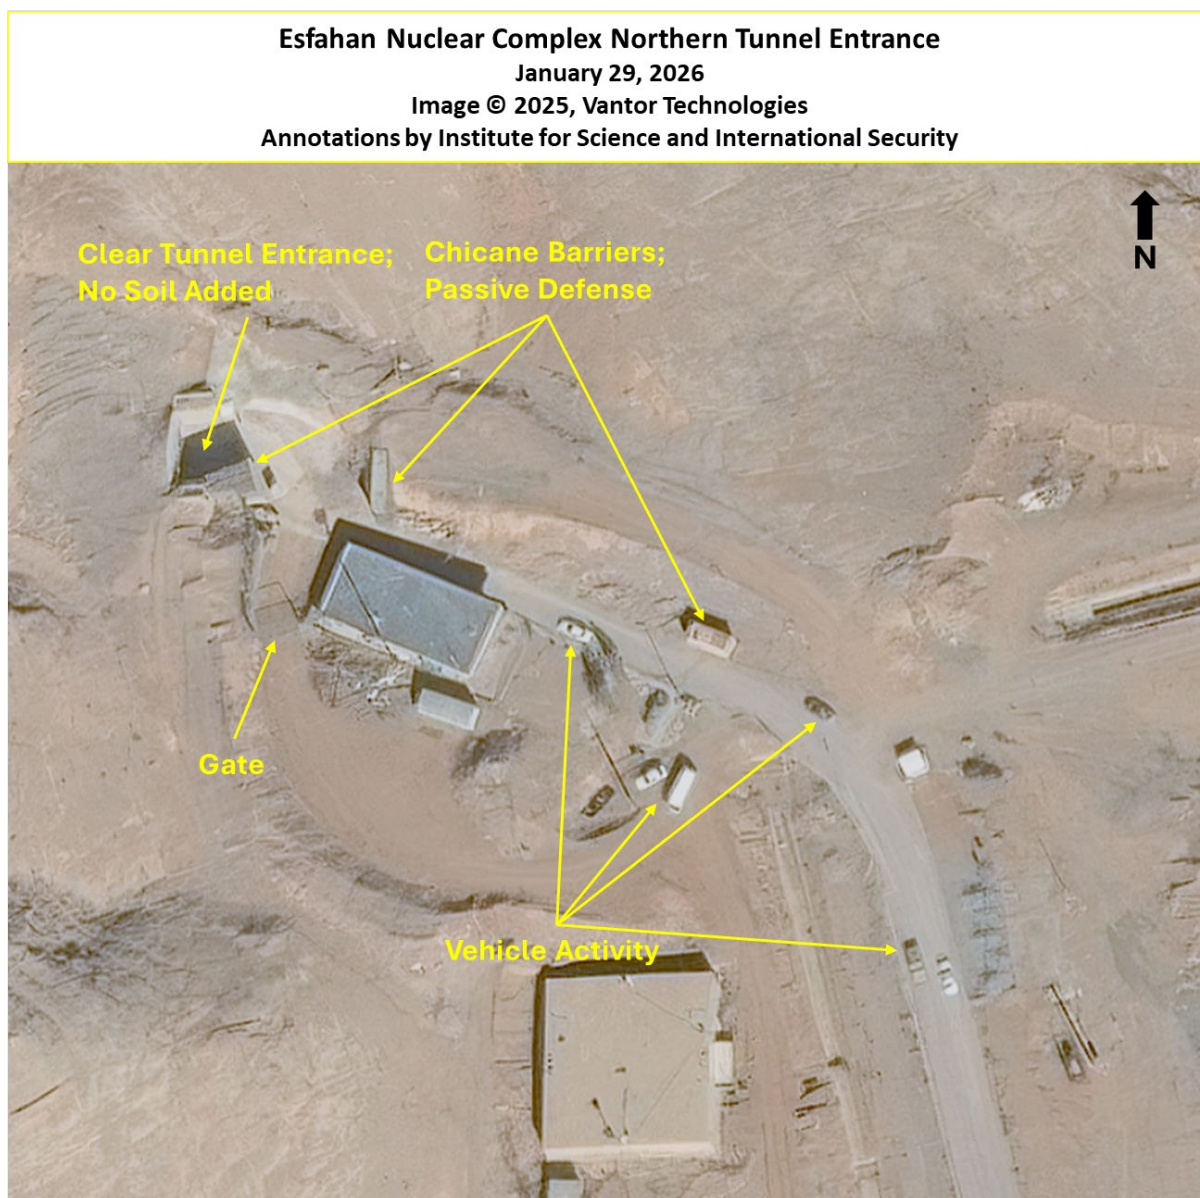
**Figure 4.** The northernmost tunnel entrance appears to remain open and vehicles are present near the entrance.

addition of missile chicanes, is less evident. The entrance seems to remain open as of January 29 with vehicles present near the entrance, raising the question whether Iran is moving recovered assets from other sites into the tunnel. See Figure 4.

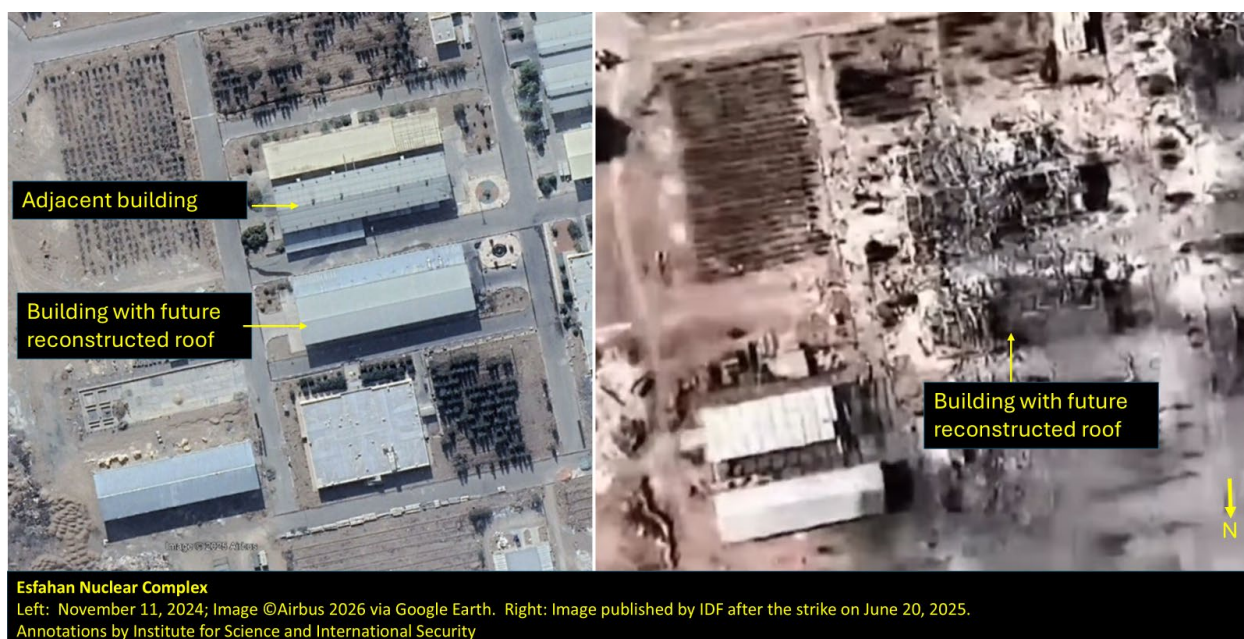
**Figure 9.** A side by side of the buildings at Esfahan before the strike and the post-strike image published by the IDF.

While the IDF did not identify a specific building, the IDF associated the area where the building was as housing centrifuge manufacturing, and it indicates that two separate buildings were involved in centrifuge manufacturing.<sup>2</sup> Figure 9 shows post-strike imagery published by the IDF, where the building discussed in this report are in the center.
